Wind Turbine Gearbox Condition Monitoring Round Robin

**2011 Wind Turbine Condition
Monitoring Workshop**

Outline

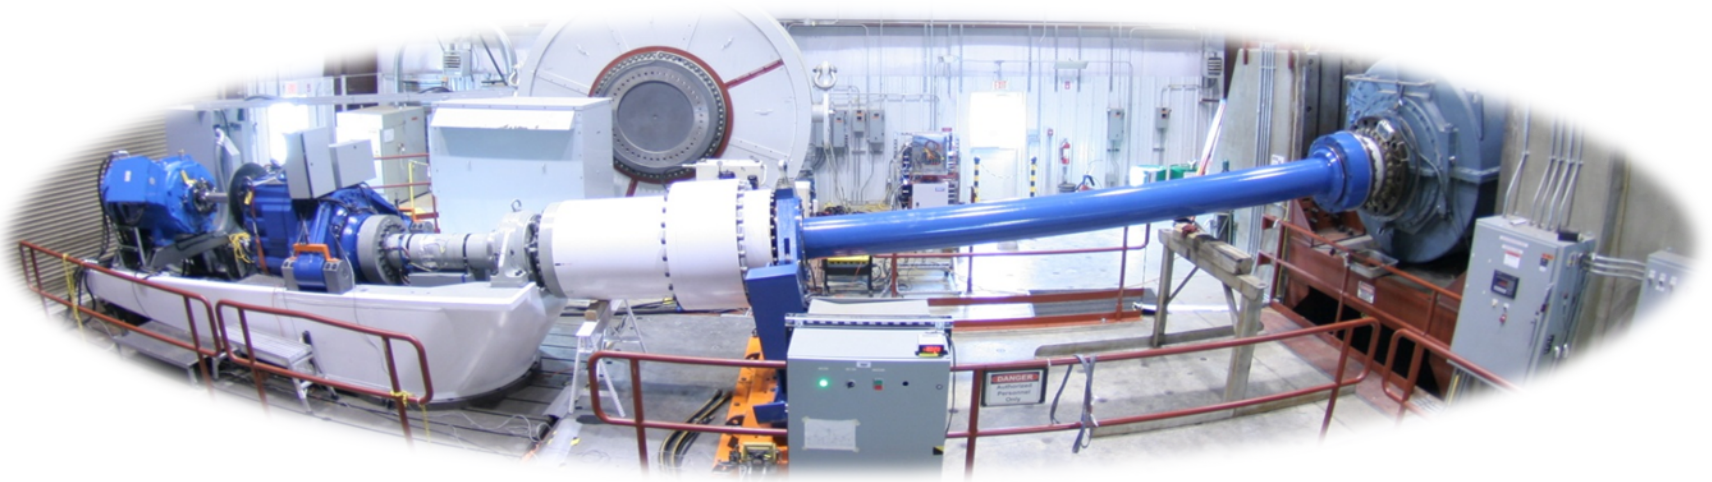
NREL 2.5 MW Dynamometer/PIX16913

- If retested in the dynamometer under controlled conditions:
 - Collect data for evaluation of different technologies investigated by the GRC already
 - Enable a CM round robin study for evaluating different vibration data analysis algorithms

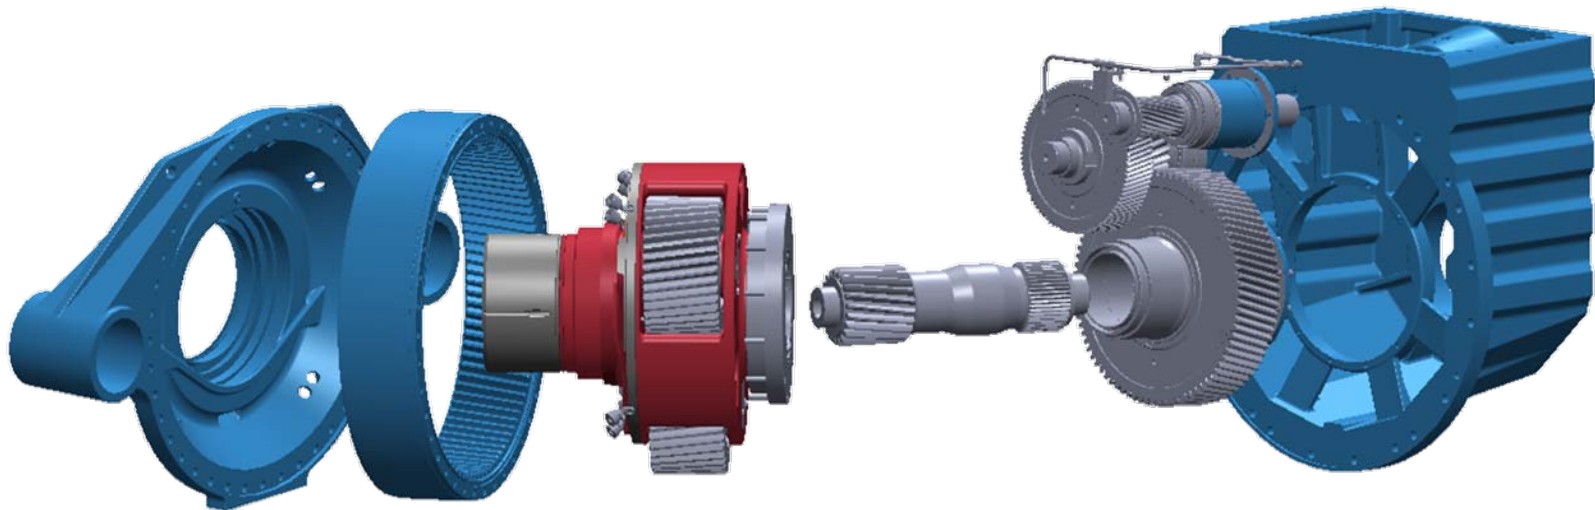
- Rated at 750 kW
 - One planet stage and two parallel stages
 - Redesign
 - ❑ Floating sun, cylindrical roller planet bearings, tapered roller bearings in parallel stages, pressurized lubrication, offline filtration and desiccant breather
 - Up to 150 channels of measurements for loads, displacements, and temperature

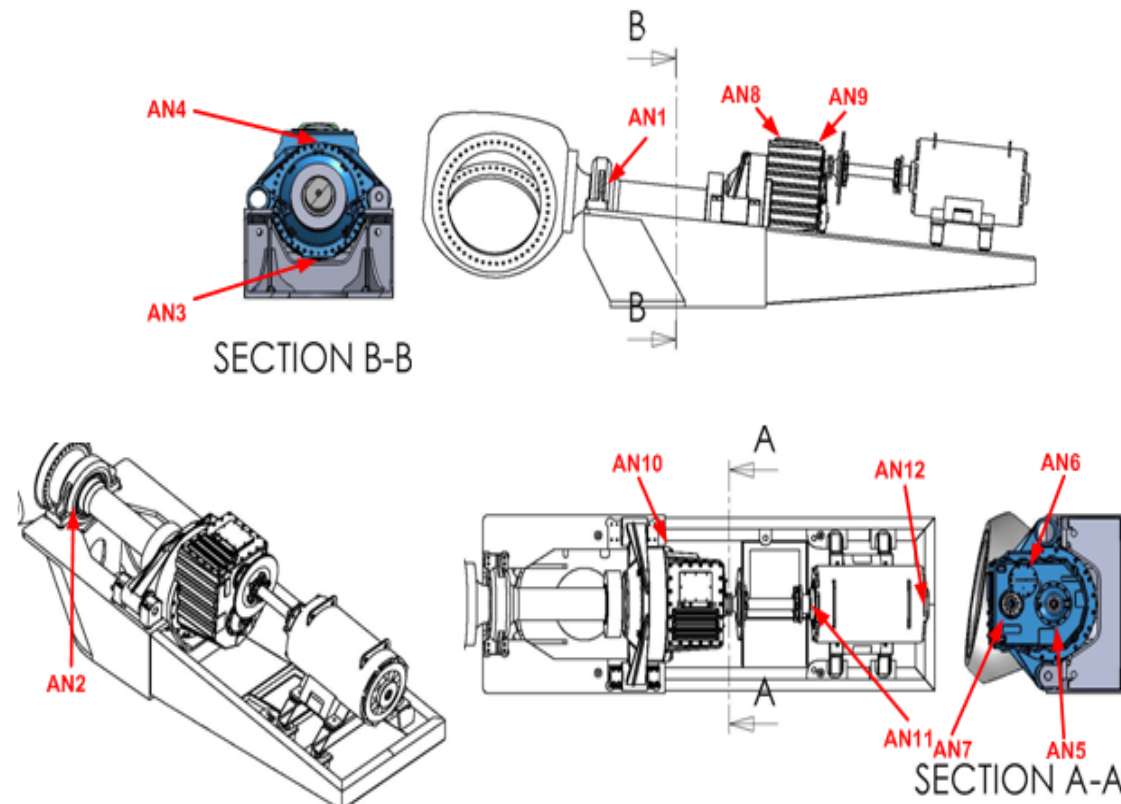
Test Setup: Sensor Placement

Sensor Label/ Signal Name	Description
AN1	Main bearing radial
AN2	Main bearing axial
AN3	Ring gear radial 6 o'clock
AN4	Ring gear radial 12 o'clock
AN5	LSS radial
AN6	ISS radial
AN7	HSS radial
AN8	HSS upwind bearing radial
AN9	HSS downwind bearing radial
AN10	Carrier downwind radial
AN11	Generator upwind radial
AN12	Generator downwind axial

- Two Typical Configurations Used by the Industry: both have 8 sensors; difference is replacing AN 5 to 7 by AN 8 to 10.

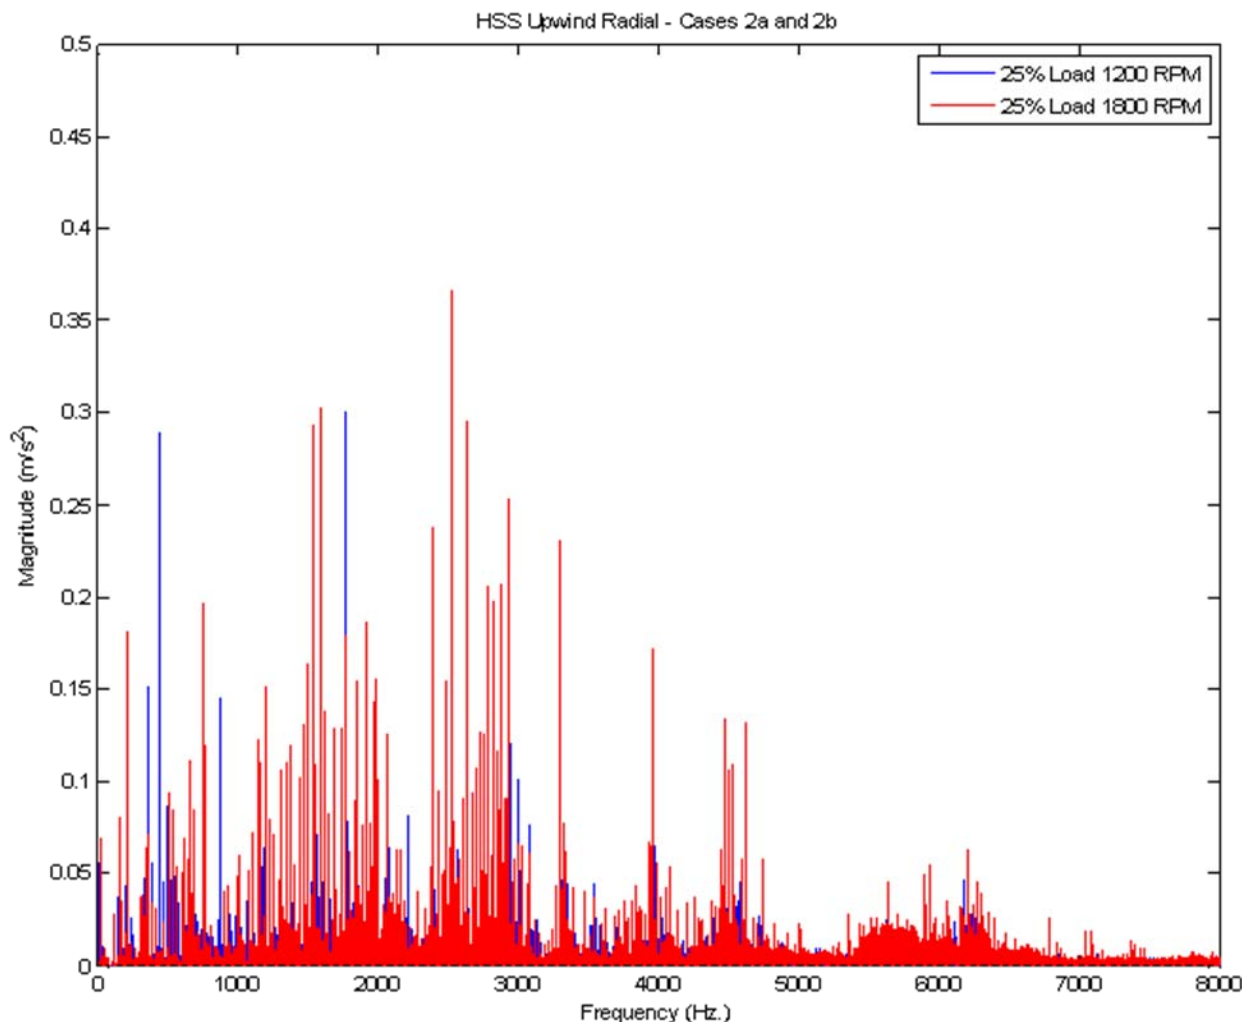
- 0-8 kHz spectrum for AN8_HSSFrontRadial, cases 2a and 2b;
- Lots of spectral content;
- Most of the fundamental gear mesh frequencies stand out very prominently along with their harmonics;
- Predicted frequencies match measured frequencies.

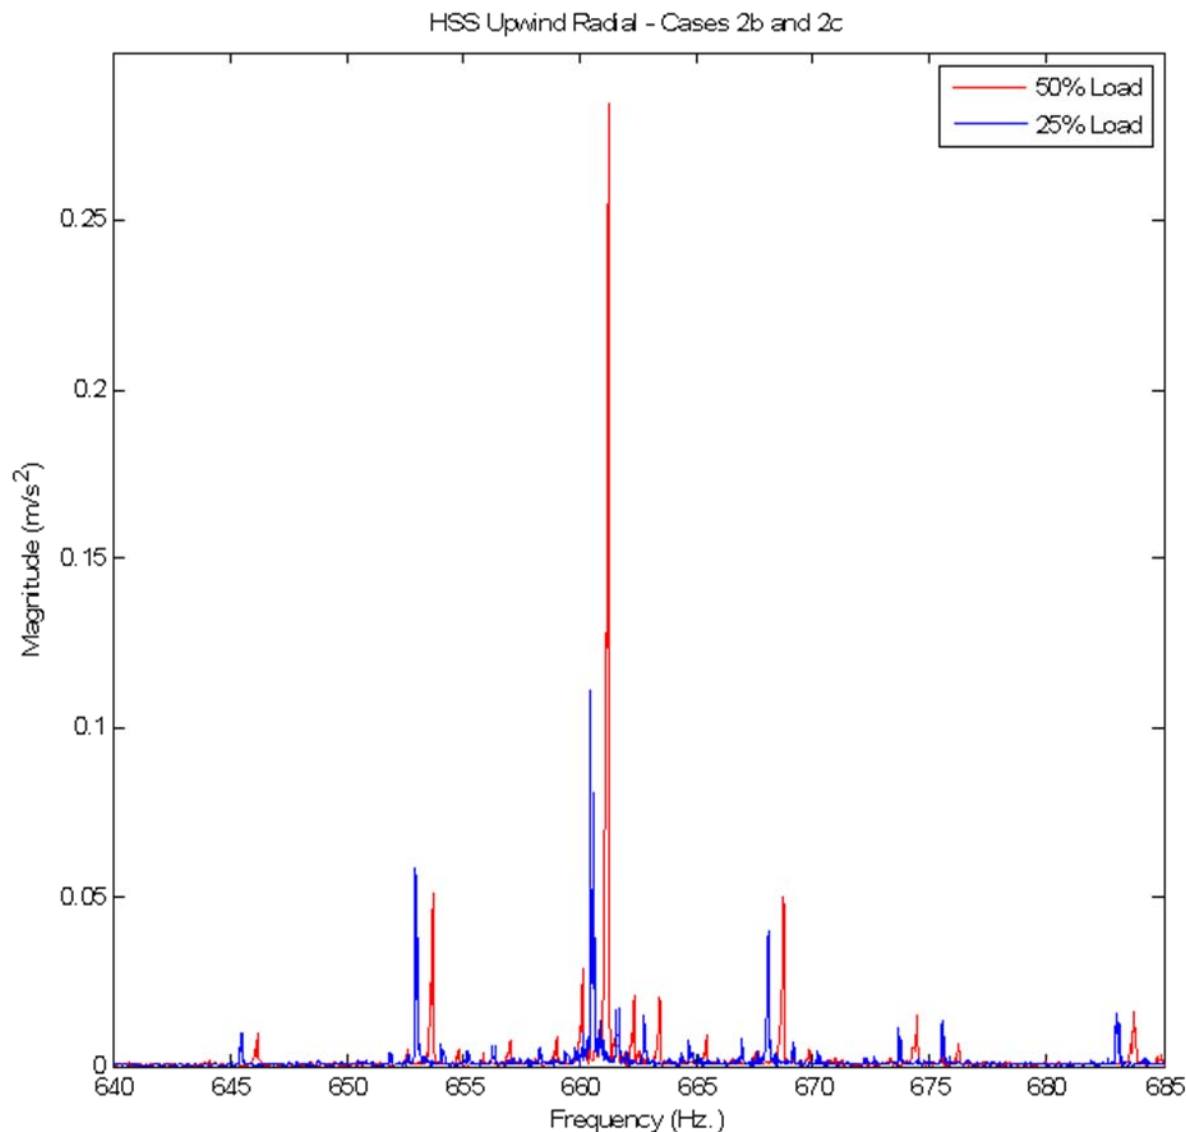
- Detail of ISS/HSS mesh frequency for cases 2b and 2c from sensor AN8_HSSFrontRadial.
- Fundamental mesh frequency prominent.
- Frequency shift between 2b and 2c correct due to generator slip.
- Change in relative magnitudes reasonable given increased loads.
- Side bands at ± 7.5 Hz, modulation by the 450 rpm (7.5 Hz) ISS shaft.

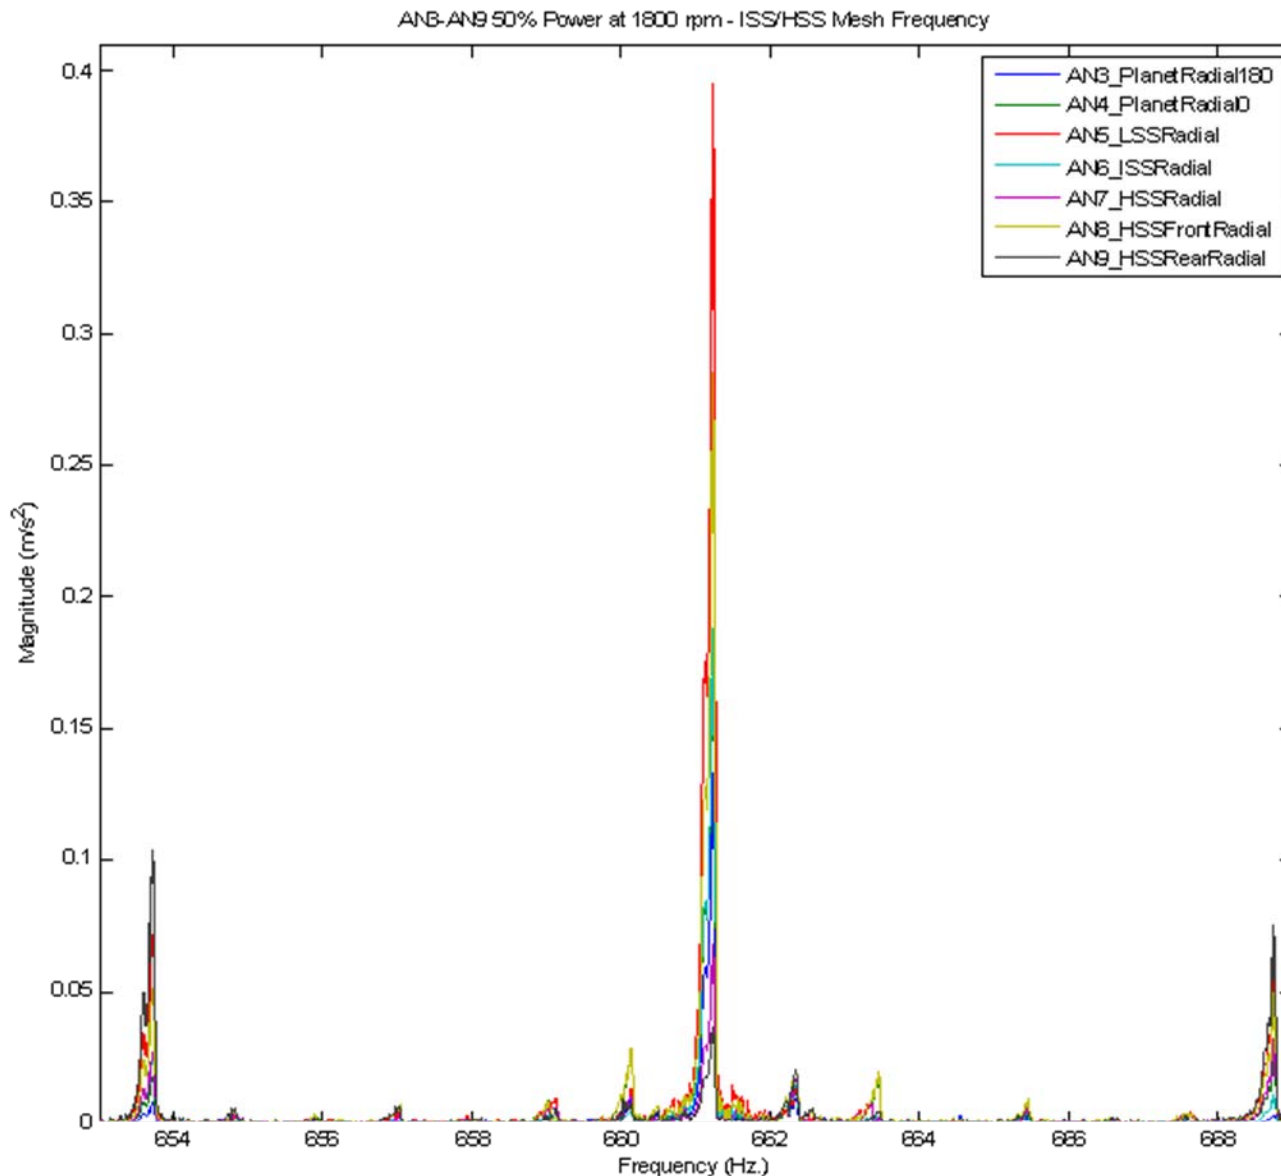
- Sensors AN3 through AN9 at the ISS/HSS mesh frequency, case 2c.
- The relative magnitudes of each sensor vary with location, but they all appear to detect the same vibration signatures (frequency components).
